HOMESPEC

June 12, 2009

Location: Home Owner Property
100 Any Street
Livermore, CA 95000

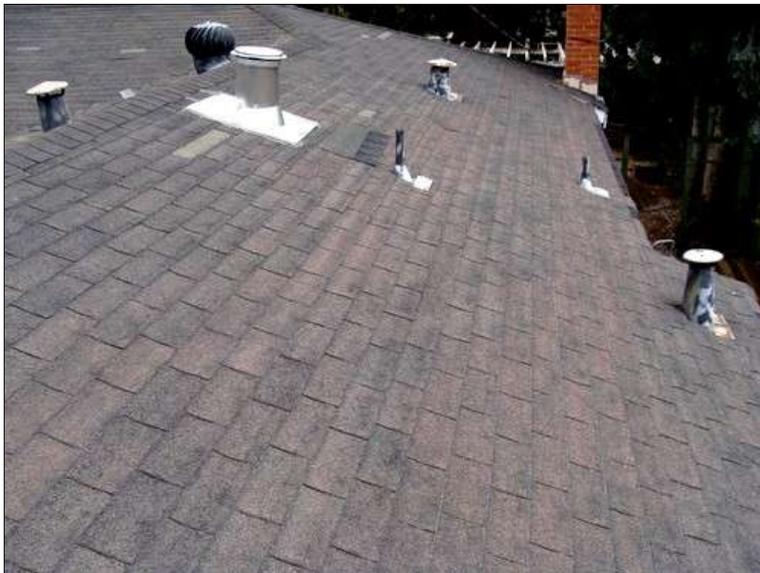
PHOTO 1 : An overview of the southern facing roof slope displays the aged and deteriorated condition of the shingles with displacement that has been influenced

by wind-related activities. Displacement of shingles that has been affected by wind-related activities and a result of the installation methods used that promotes seal tab defeat, allows the shingles to be susceptible to uplift in certain wind conditions. Age-related drying of the seal tab assemblies is also contributing to the cause of uplift. As the roof ages the seal tabs begin to dry and lose the intended

bonding capability and is an indication that the roof is near or at the end of a practical service life.

On the south-exposed roof area the shingles are significantly weathered and aged. The granules have been displaced or washed off for a reasonable amount of time revealing the underlying components of the shingles. Exposure of the shingle components that are not intended to be revealed to the elements will accelerate their deterioration and can allow sources of moisture migration beneath the roof during periods of inclement weather when saturating conditions develop. This is an indication that the roof is no longer providing adequate service and requires removal and replacement.

The starter course of shingles have been improperly installed which has promoted displacement above the eaves. There is no provision of a sheet metal rake flashing and the shingles do not adequately overhang the edge of the roof to compensate. A sheet metal flashing component has been installed over the shingles at the attic vent penetration. The remaining flashings at roof penetrations have been installed in accordance with accepted roofing practices with the exception of the chimney. The recommended step flashings have not been provided at the sides of the chimney penetration.

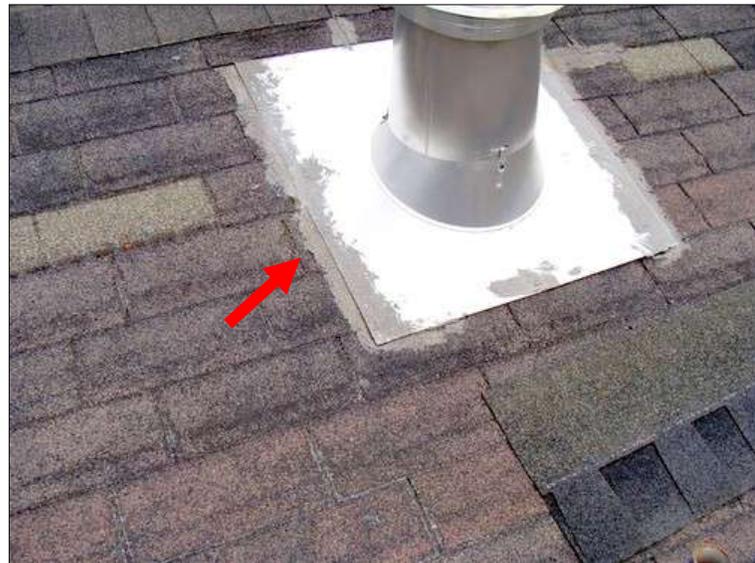
PHOTO 2 : At the attic vent penetration, the sheet metal flashing is installed above the roof rather than being properly transitioned to the shingle courses. The penetration has also been provided mastic seals that are aged and deteriorated. This installation method can allow moisture migration below the roof at these penetrations during

periods of inclement weather when saturating conditions develop, which can subsequently appear as interior water incursion. The preferred installation method is to conceal the upper and side portions of the sheet metal flashing components with the lower portion left exposed to allow an exit path for any moisture that inadvertently migrates into the upper location of the penetration. At the time of roof replacement it is recommended that proper sheet metal flashing components be provided and installed to accepted trade standards. An abandoned shingle panel is lying upon the roof that can hinder drainage. Unwanted debris should not be allowed to accumulate on the roof surface to help prevent impeding the flow of water down the roof slope.

Also visible in this close up are displaced shingles that are the result of age related deterioration of the seal tab assemblies which bond shingles together and the improper placement of fasteners in the seal tab assemblies. The proper placement for fasteners is directly below the seal tab, one inch from the edge, and should incorporate four, evenly spaced fasteners per panel. These shingles have been displaced for an extended period of time indicated by the rusted nature of the exposed fasteners.

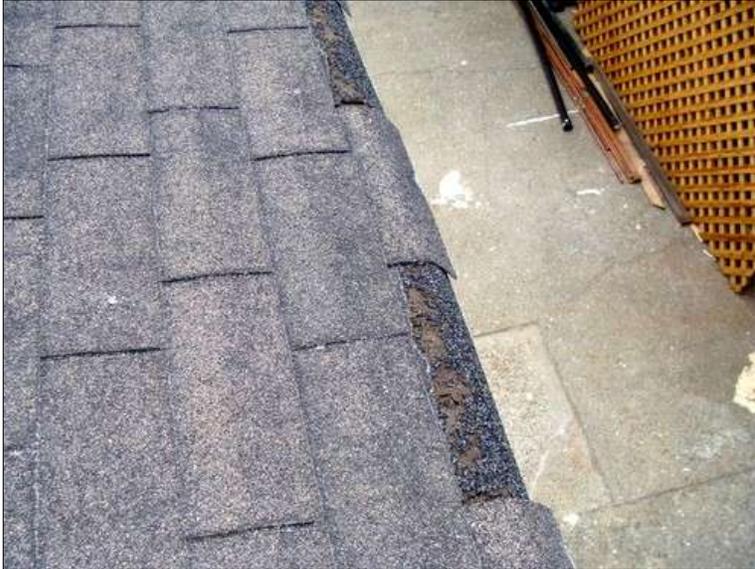
PHOTO 3: The starter course of shingles have been improperly installed inverted, or

upside down. The seal tab assemblies are too high into the field area of the roof and have not allowed the first course of shingles to bond to the roof. Displacement has therefore resulted due to easily lifted shingles above the eaves.

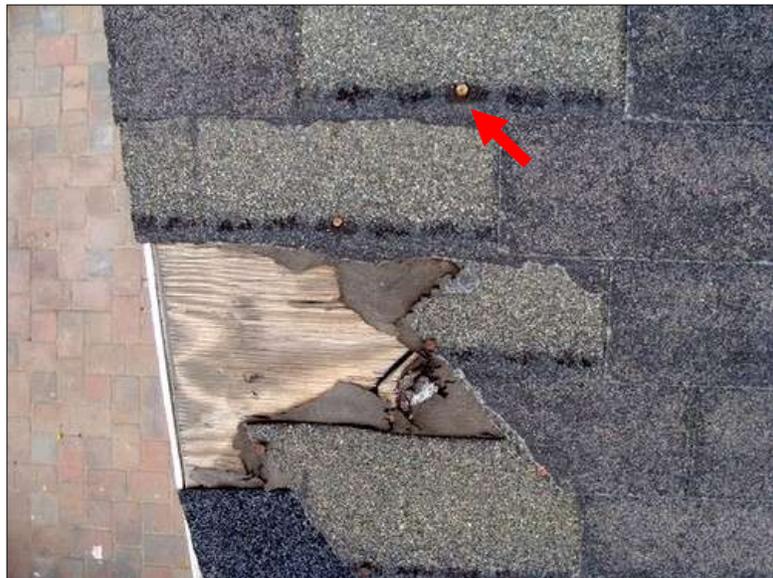
PHOTO 4: The perimeter sheet metal flashing components at rake locations have

not been provided as recommended. This can allow moisture influence below the roof during periods of heavy continuous rain and wind. A close-up of shingle panel adjacent to displacement locations reveals the fasteners installed through the seal tab assemblies, as indicated by the arrow. While this is a commonly used practice, it is not in accordance with manufacturer recommendations and accepted

trade standards. This installation method will promote defeat of the seal tab assemblies and subsequent uplift and/or displacement. The proper placement for fasteners is directly below the seal tab, one inch from the edge, and should incorporate four, evenly spaced fasteners per panel.

The aged and deteriorated condition of the exposed substrate and underlayment indicates that moisture influence to this location has been occurring for an extended period of time rather than being a recent occurrence. While typical remedial repairs of displaced shingle panels would incorporate 'flat-bar', replacement, and hand sealing methods, they will not assist the roof in achieving long-term service due to the extent of seal tab defeat at various roof locations and as it is reasonable to expect that these conditions will continue to develop.

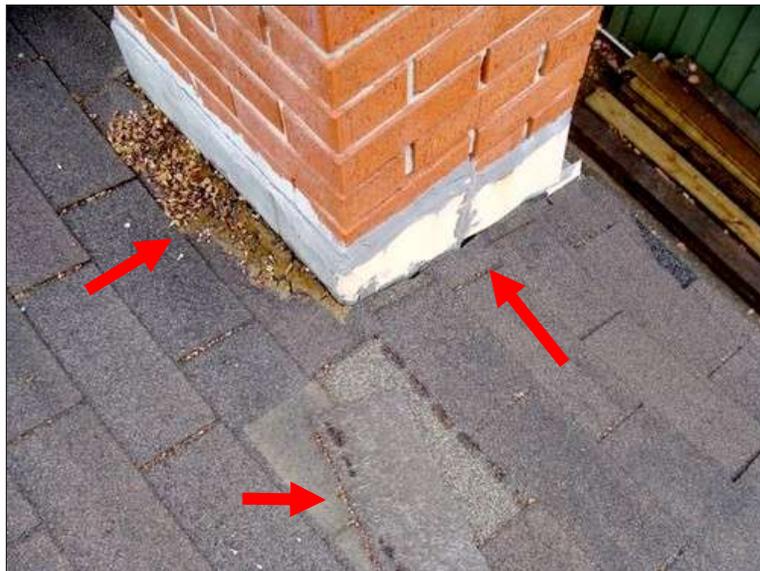
PHOTO 5 : At the roof-to- chimney transition the proper sheet metal step flashing

components were not provided and interwoven with each individual course of shingles as is recommended at the sides of the chimney. This transition has not been provided with sealant to help compensate for the lack of proper flashings. This can allow saturation of the transition with moisture during

periods of heavy continuous rain, accompanied by wind and a source of moisture influence into the interior and/or wall components. At the time of roof replacement it is recommended that proper sheet metal step flashing components be provided and installed to accepted trade standards. The accumulation of debris behind the chimney can restrict the intended run-off of moisture around the chimney during periods of heavy continuous rain. This can subsequently allow overburdening of the transition where water can migrate up and under the shingles and/or *wick* into the side-wall components of the chimney when saturation develops. Regular roof maintenance should include cleaning of transition locations as necessary. Also visible is another displaced shingle from age related deterioration and improper fastener placement.

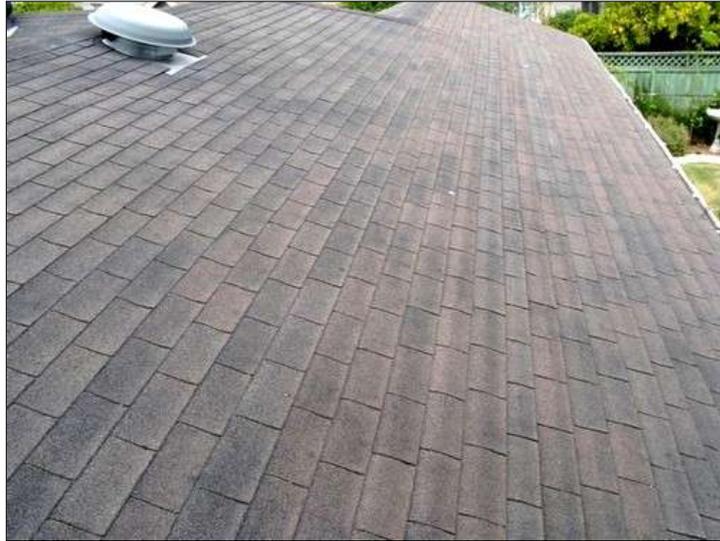
PHOTO 6 : An overview of the main, eastern facing roof slope at the rear of the structure. There is no damage or displacement at this location from storm related activity or as a result of the previous fire. The shingles are experiencing minor to moderate granule loss or *wash off*. There are fasteners backing out of the roof and through the overlying shingles in limited locations.

The shingles can be easily lifted in various locations from seal tab defeat and are susceptible to possible displacement. Roof penetrations have been installed in accordance with accepted roofing practices.

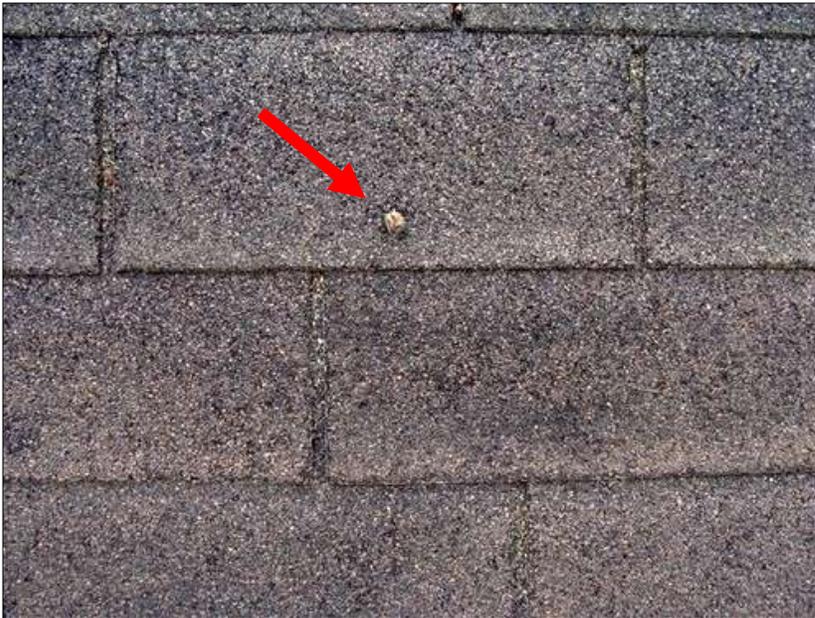
PHOTO 7 : Fasteners are protruding through the surface of the overlying shingle

panel as illustrated here. This condition suggests isolated fastener back out has occurred which is occasionally promoted by normal building motion and settlement. The fastener has been exposed over an extended period of time due to the development of rust, indicating lack of adequate roof maintenance that has been provided. These protruding fasteners have compromised the

waterproofing abilities of the overlying shingle and can allow moisture to *wick* under the roof at the point of fastener penetration during periods of inclement weather when saturating conditions develop and allow sources of moisture migration beneath the roof through the point of fastener penetration. At minimum, removal and replacement of this shingle should be provided in conjunction with normal roof maintenance. The extent of backing out fastener are

an indication that the roof is not providing service as intended and should be considered for removal and replacement.

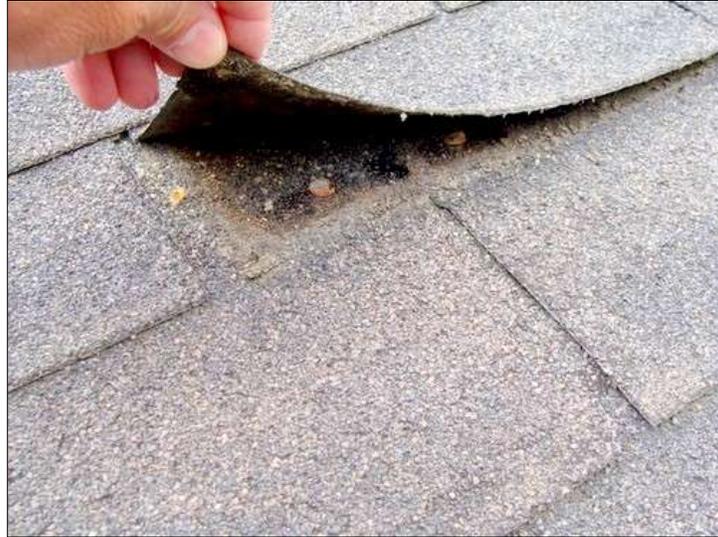
PHOTO 8: The shingles could be lifted with passive hand pressure indicating seal tab defeat and improper fastener placement through the seal tab assemblies, as indicated by the arrow, and age related drying of the seal tabs. The proper placement for fasteners is directly below the seal tab, one inch from the edge, and should incorporate four, evenly spaced fasteners per panel. Seal tabs are intended to bond the shingles to one another to prevent wind uplift. As the seal tabs become defeated it is an

indication that the roof is nearing or has reached the end of its reasonable service life. The presence of rusty fasteners and the accumulations of dirt and debris below the shingles is an indication that seal tab defeat and uplift of the shingles has been occurring for an extended period of time, rather than being a recent event.

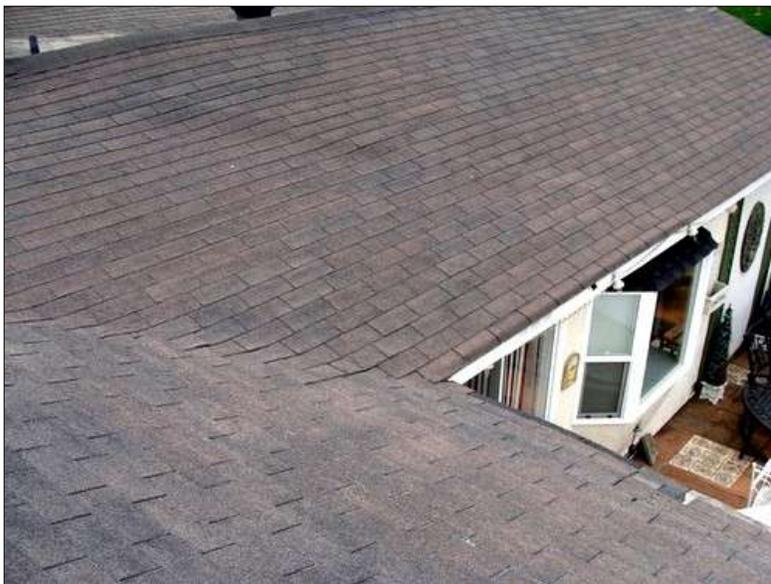
PHOTO 9: An overview of the northern and western facing roof slopes. There are a limited number of displaced shingles as a result of drying of the seal tab assemblies and improper fastener placement. Similar conditions above the eaves are present where the starter course of shingles have been improperly installed and are easily lifted from lack of bonding to the roof. The shingles have been improperly weaved in the valley where water entry may occur.

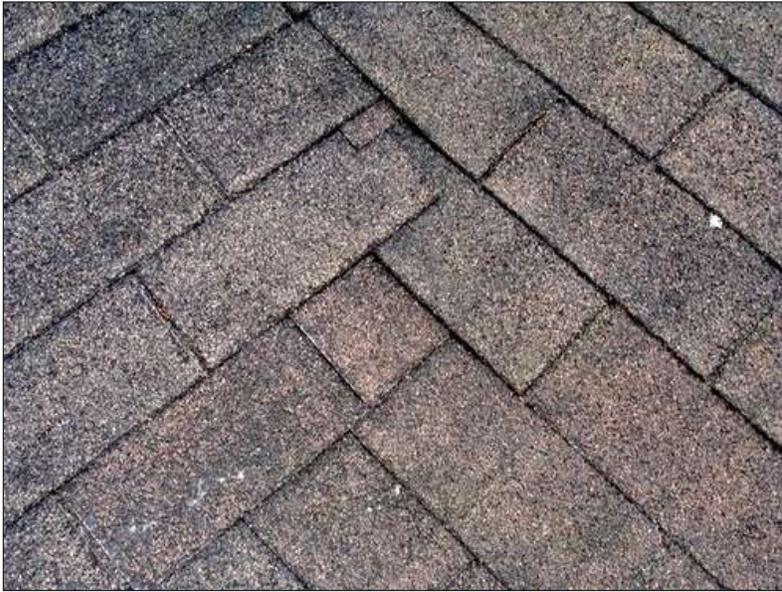
PHOTO 10 : The arrow indicates where the shingles are inappropriately placed in a valley location. The laps of the roof will not adequately shed water run-off and can become overburdened with moisture during periods of inclement weather when saturating conditions develop. Continued moisture influence or repeated water migration under the roof will be detrimental to the intended service life of the roof and related components and will eventually allow sources of interior water incursion below.

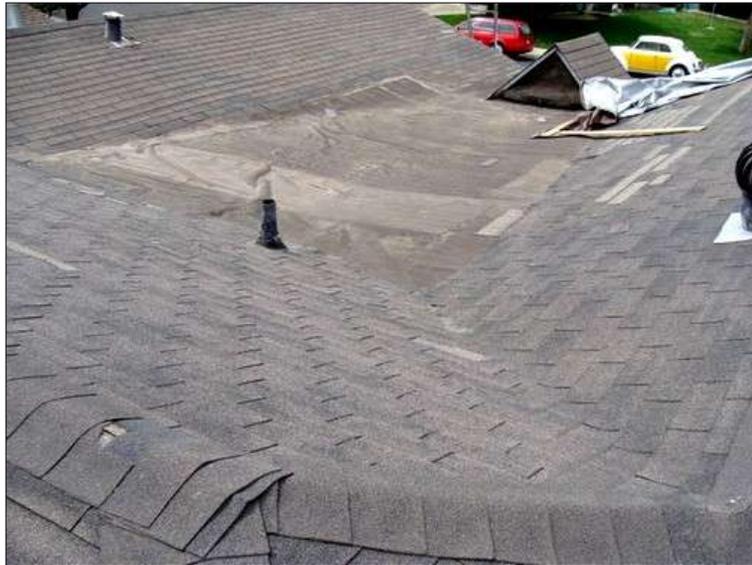
PHOTO 11 : An overview of the modified bitumen roof in the middle-flat section and the northern, southern, and western facing roof slopes that transition into the lower flat section. Displacement of the shingles can be attributed to lack of bonding at the seal tab assemblies and improper fastener placement which has allowed shingles to be easily lifted and vulnerable to displacement. The ridge shingles are ripping and/or tearing as indicated by the arrow. This is promoted by uplift of the shingles during periods of windy weather and is an indication that some sections of seal tab assemblies have functioned properly and continued uplifting conditions have stressed the shingles.

Some flashings at roof penetrations have not been properly transitioned into the adjacent shingles. A sheet metal flashing component at the plumbing vent pipe

penetration has been completely concealed by the composition shingles. This penetration has also been provided mastic seals that are aged and deteriorated. The flashing for the attic vent penetration has been installed completely over the roof. These methods can trap moisture below the roof at these penetrations and allow sources of moisture migration through any splits or voids in the seals during periods of inclement weather when saturating conditions develop.

Similar conditions are present on the sloped sections of the roof, such as nails protruding through the overlying shingles and improper weaving in the valleys which has resulting in interior water incursion reported below.

The modified bitumen roof has been hot mopped in place and has extensive buckles developing. The roof is deteriorated and cracked, which may be allowing water entry under the roof. The modified bitumen roof does not extend underneath the shingles three courses or 18 inches as required by accepted trade standards.

Tarp assemblies have been removed by others from various locations prior to our inspection. These tarps appear to have been applied with battens and/or wood planks that were secured to the roof. These nail type fasteners likely have punctured the roof and underlayment. Where the fasteners have violated the roof, remedial repairs are now necessary.

The preferred installation is to conceal the upper and side portions of the sheet metal flashing components while leaving the lower portion exposed to allow an exit path for any moisture that should inadvertently migrate into the upper location of the penetration. At the time of roof replacement it is recommended that proper flashing components be provided and installed to accepted trade standards.

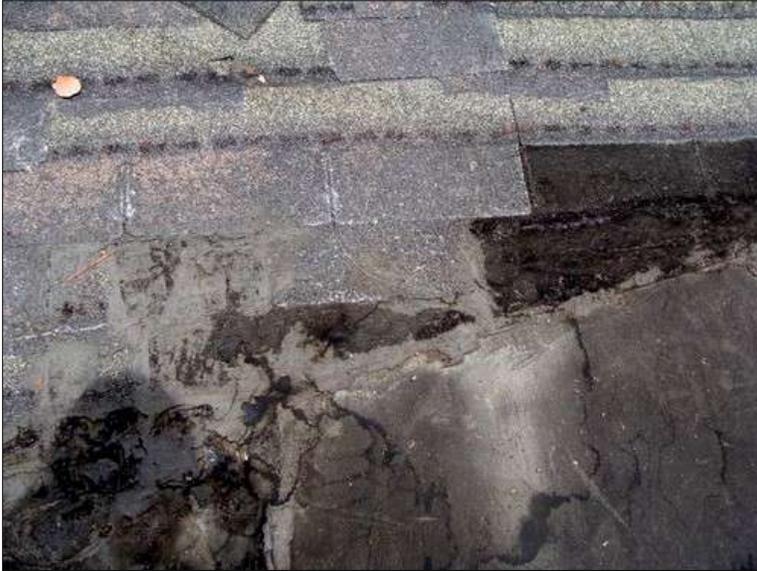
PHOTO 12: Mastic remedial repairs have been provided directly over shingles and at a limited number of laps in the modified bitumen roof, which are not necessarily

recommended as they can trap moisture below the roof. Mastic application(s) such as these should not be necessary on a sufficiently installed roof. In addition, mastic will not necessarily provide long-term weatherproof service and would be considered temporary at best. These mastic remedial repairs are further evidence that the roof is not providing service as intended and should be considered for removal and replacement.

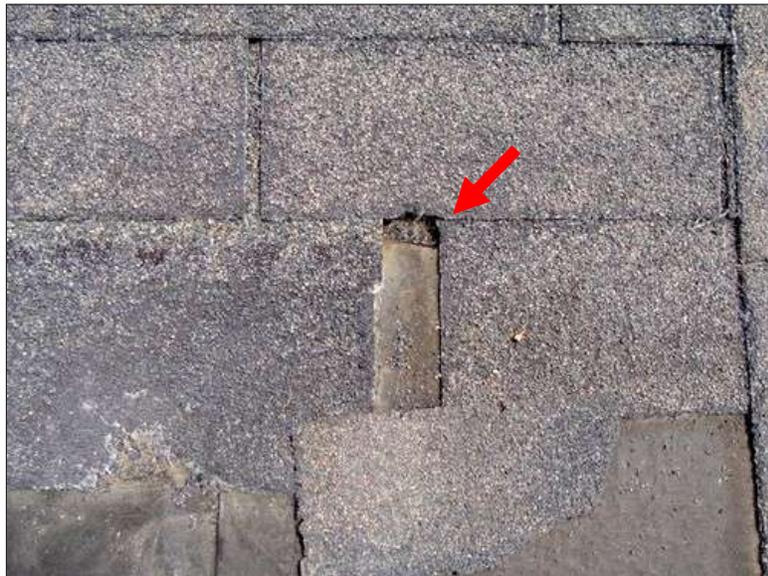
PHOTO 13: At the transition of the low-sloped roof area to the shingle application, the arrow indicates where the modified bitumen roof does not adequately extend

underneath the shingles three courses or 18 inches as required by accepted trade standards. The shingles have not been hand sealed at this transition and can be easily lifted. This transition can become overburdened with moisture during periods of inclement weather when saturating conditions develop and a source of moisture influence into the interior. At the time of roof replacement it is recommended that the proper transitioning be provided to these areas.

The proper base sheet does not appear to have been installed under the roof. The modified bitumen roof is not bonded or mechanically attached to the roof and can be easily lifted and allow water penetration, contributing to interior moisture influence below.

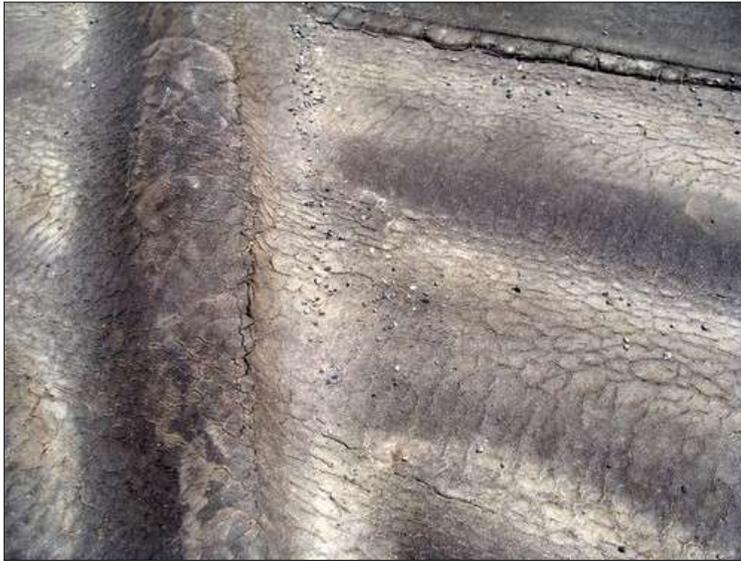
PHOTO 14: A continuing close-up of the modified bitumen roof displays raised areas which are often referred to as buckles. This condition can result from substandard

mechanical attachment of the roof to the substrate. These buckles can rupture and become overburdened with moisture during periods of inclement weather when saturating conditions develop as well as a potential source of water incursion inside the structure. The development of buckles in a modified bitumen roof typically indicates that the roof is nearing or has reached the end of its

intended service life. The surface of the roof is aged, deteriorated, and has cracked over time. Removal and replacement of this roof should likely be addressed at this time.
